EXCAVATIONS ON THE ROMAN VILLA AT BEADLAM, YORKSHIRE

**YORKSHIRE
ARCHAEOLOGICAL
REPORT No 2.**

YORKSHIRE ARCHAEOLOGICAL REPORT No. 2
Yorkshire Archaeological Society, Roman Antiquities Section
1996

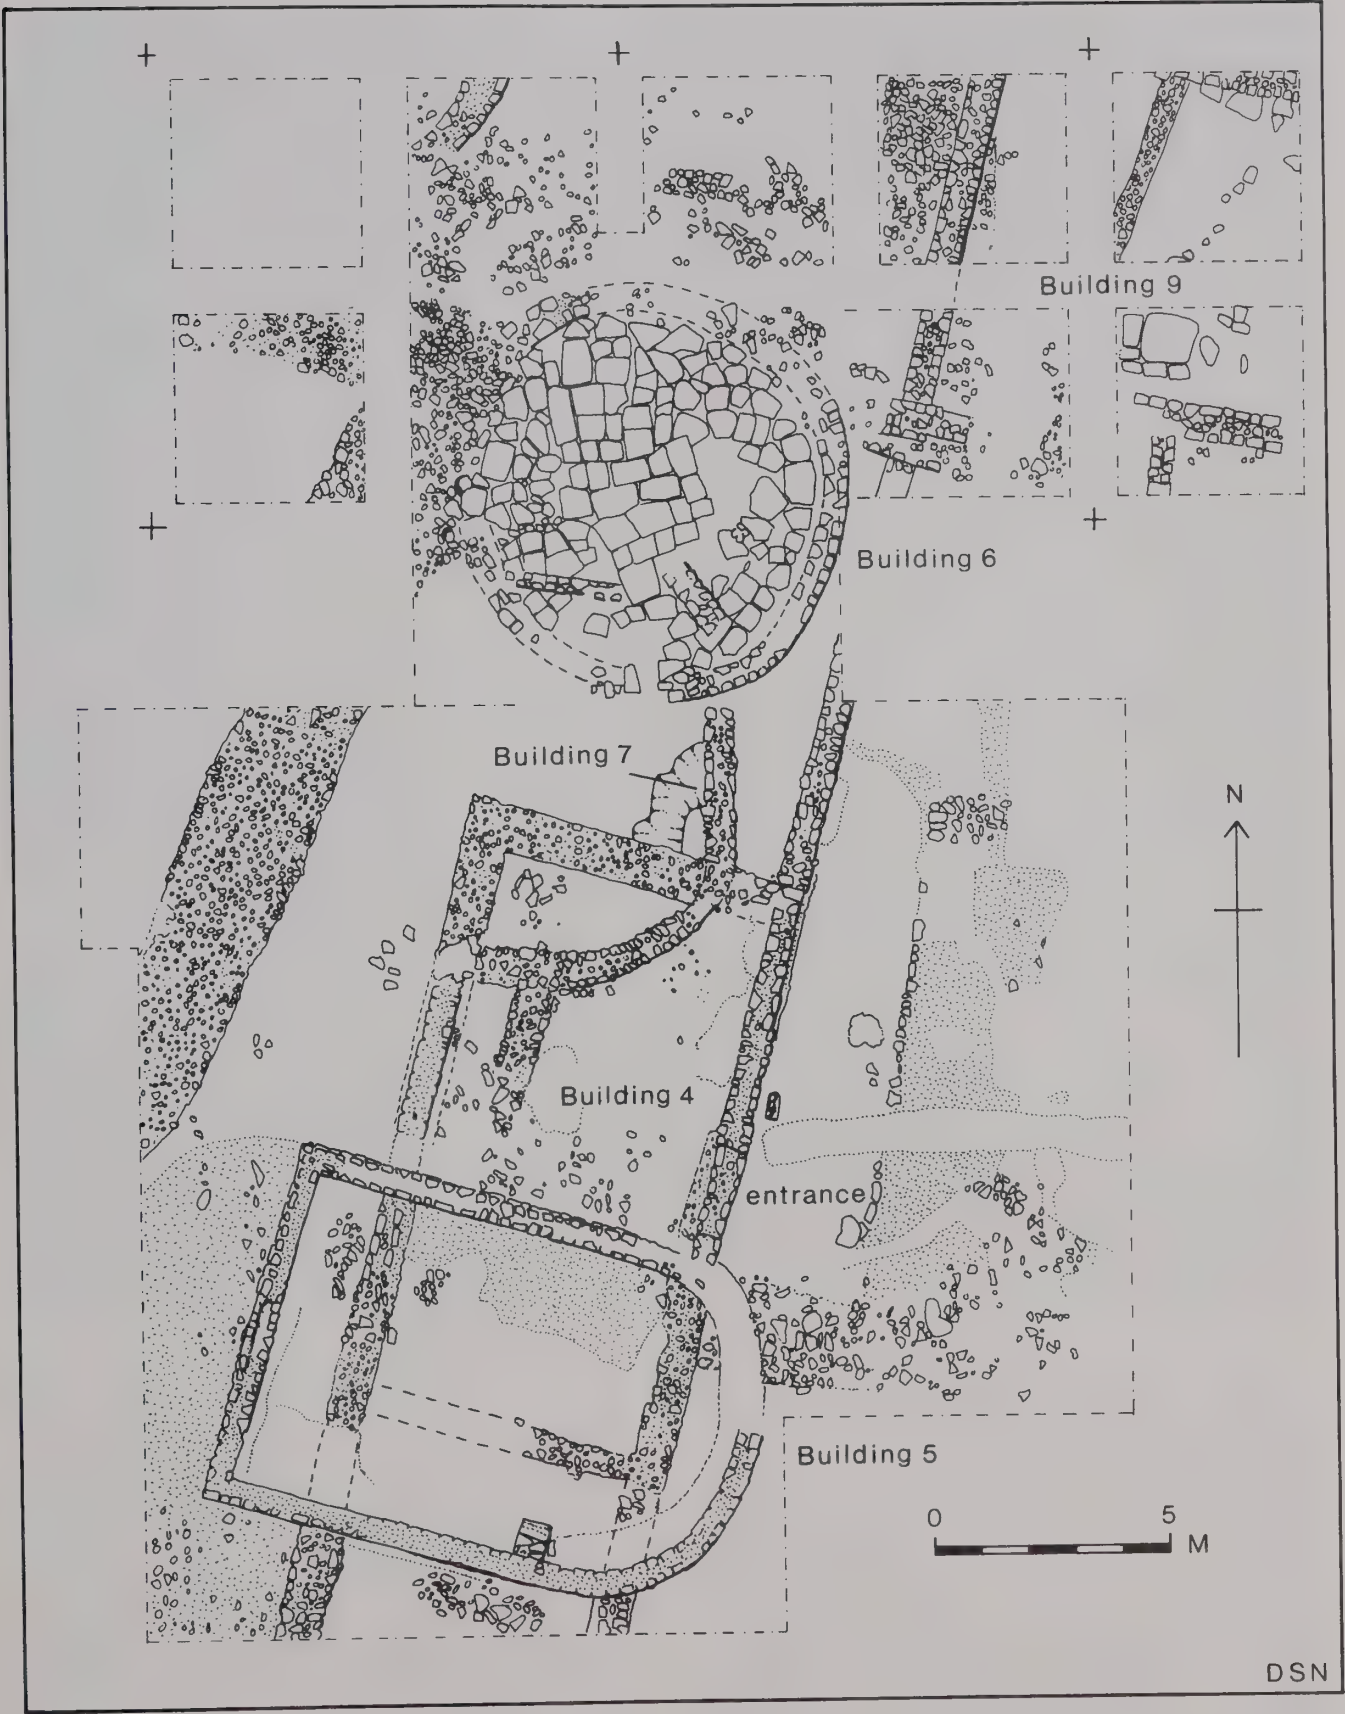
Fig. 26 Plan of Buildings 4-7 and 9, the East Range.

The range has a complex sequence of development and even though the depth of excavation was restricted, four or five phases can be established from a study of the plan. Its development is further confused when questioning the relationship of the complex to unexcavated buildings situated to the west and located by the geophysical survey. To the west an almost square structure, Building 10, had its west wall on the same alignment as the east wall of Room 10 in the North Range - a similar situation to the West Range where the east wall here was aligned on the west wall of Room 12. Possible explanations for this will be given in the Discussion. The dominant alignment in the East Range is a north-south wall which

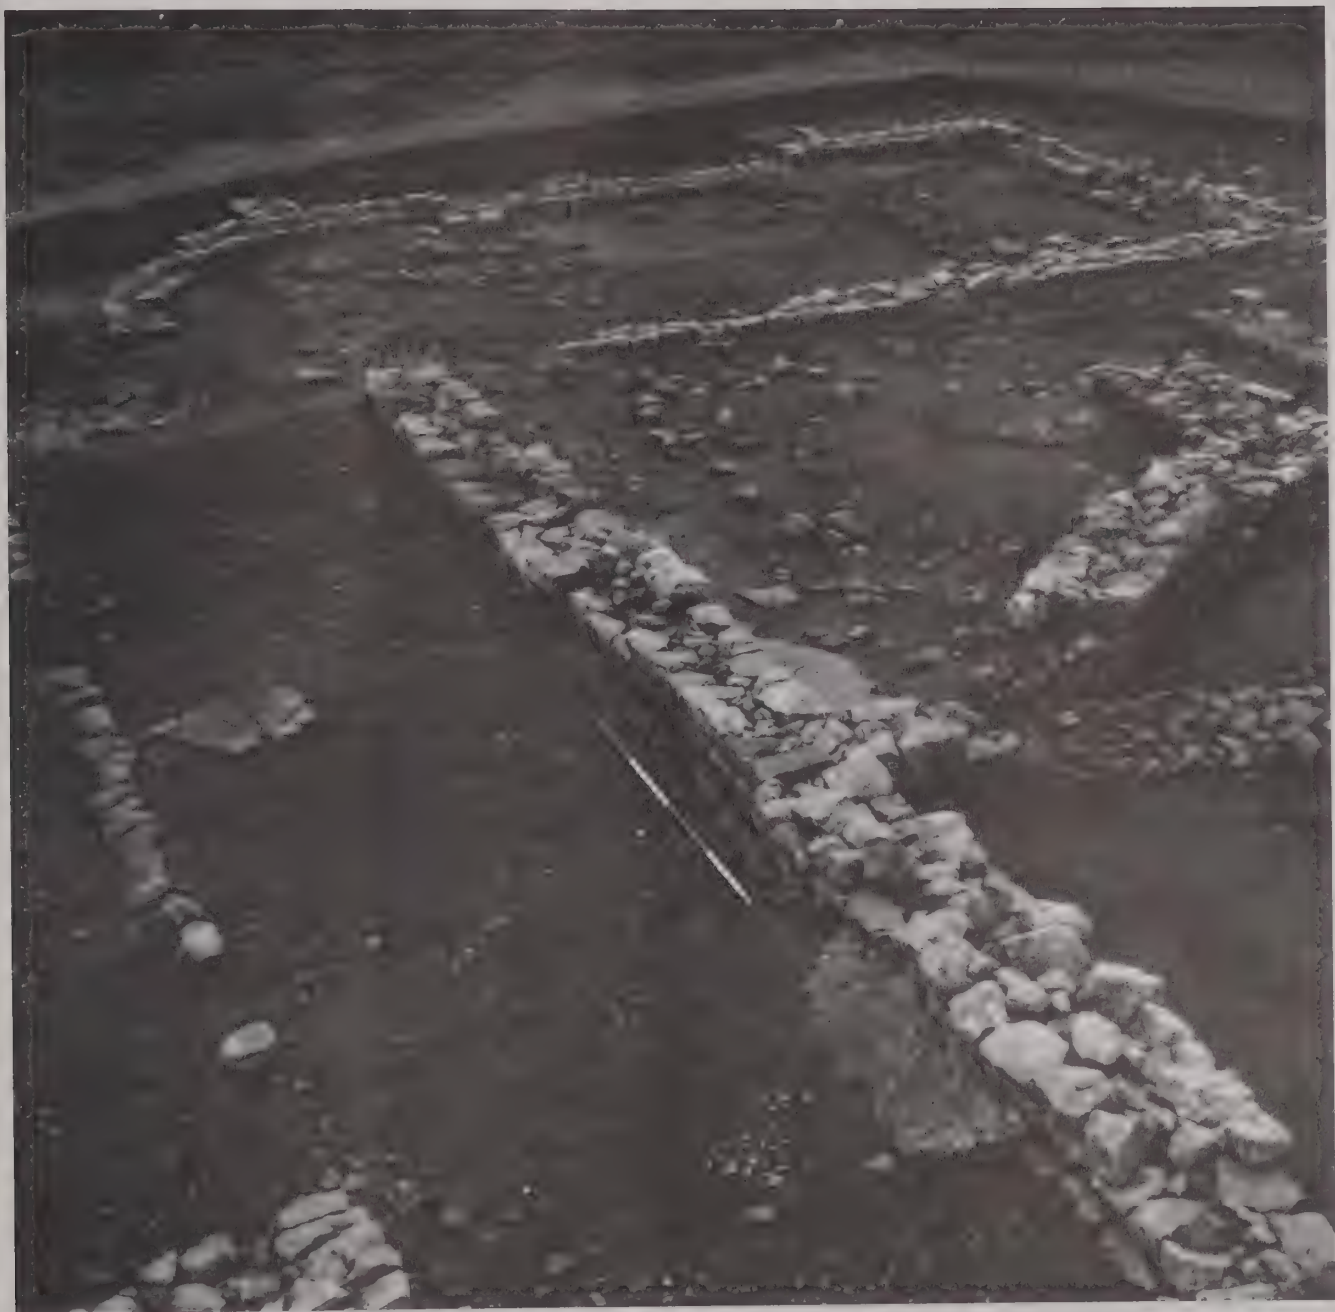
Fig. 27 The East Range. Detail of features to east of Buildings 4 and 5. View south-west.

Whether the boundary wall existed prior to the construction of Building 4 is hypothetical. However, the east wall of the new building shared the same alignment and was constructed on a foundation of rounded, pitched, river pebbles set in clay supporting walls of limestones with calcareous gritstone quoins. The pebbled foundation was observed beneath the north and west walls as far as the southern edge of the excavation and therefore an east-west foundation of limestone is unlikely to be the south wall of the building but a partition dividing the building into two parts. The size of the building, therefore, is uncertain but it was at least 18.00m long by 7.75m wide overall (the geophysical plots do not show its full extent). However, there is circumstantial evidence that its south wall may have turned directly beneath the excavator's baulk and that the building was about 18.40m long. The reason for suggesting this is the presence of a metalled pathway approaching the east side of the building. It is likely to have been axial to its length and to have served the building before it was later converted by the partition into two. A new entrance for the northern part of the building was then inserted through the existing wall midway along the new room which measured 6.40m wide by 11.90m long. The new entrance was 1.20m wide but was subsequently blocked with pitched limestones (Archive Photograph 252).

The floor of the building was originally paved with stone flags bedded in orange clay. Unfortunately, most of the flags had been removed but a single example was preserved in the

north-east corner (Archive Photograph 267). Other features possibly broadly contemporary with the building were a stone-packed post-hole in the north-west corner and a large rotary quern (location in building not established) with a diameter of between 1.00m-1.25m. Whether this was being reused as paving is a possibility but a stone of this size must have been a mill and not a hand quern. It follows, therefore, that one of the buildings in the complex was being used for milling (for further discussion see p. 43). A stone loom or thatch weight (Fig. 42, No. 123) was found east of the building.

Building 4 (Figs. 27 and 28)

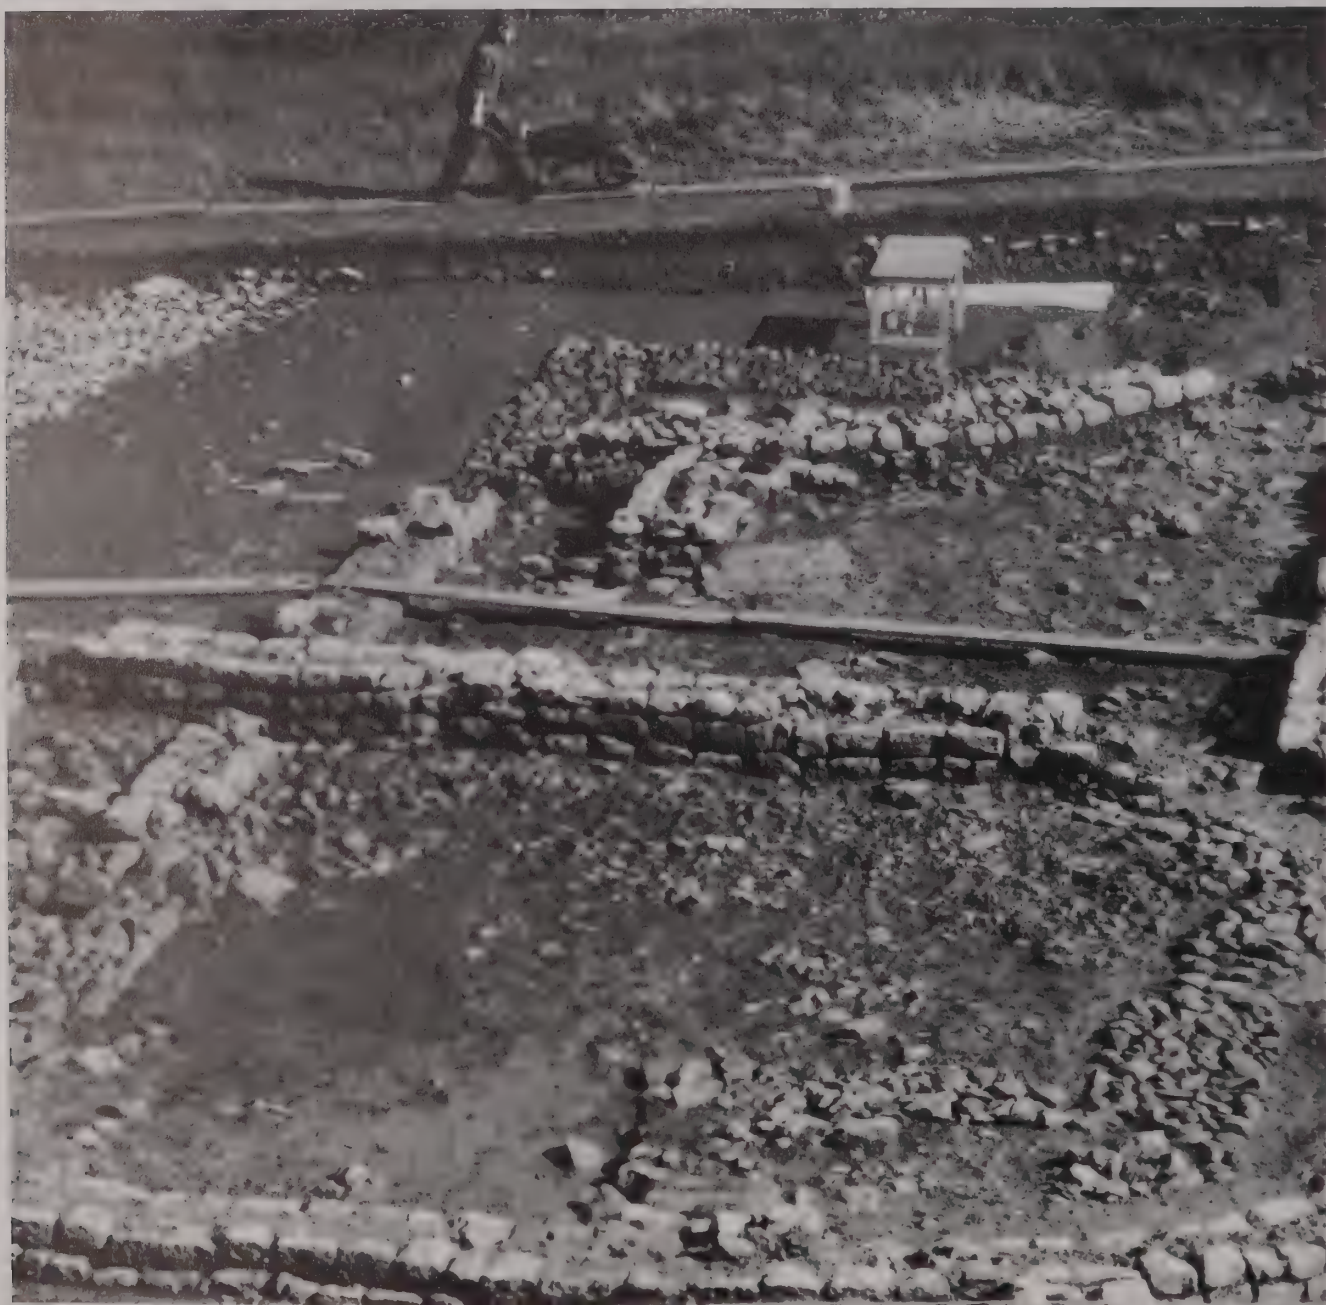
Fig. 28 Overall view of Buildings 4 and 5. View north.

Reference to the boundary wall having possibly predated Buildings 4 and 5 has already been made. However, with the demolition of Building 4 it is almost certain that the east wall

of the building was only partly dismantled and used to create an extension of the yard wall to the north and south. The reason for suggesting this is that where the foundations and walls of Building 5 breached the earlier east wall of Building 4 the new clay foundations were sealed on both the north and south sides by an infill of masonry which closed the gaps that the foundation trench had created (similar infilling did not occur on either side of the original west wall). Unless the earlier wall was retained this situation would not have occurred. Further clues that the east wall of Building 4 became an extension of the yard wall was the fact that the secondary doorway into it was also blocked; this is unlikely to have happened during the life of the building since the blocking sat on the latest

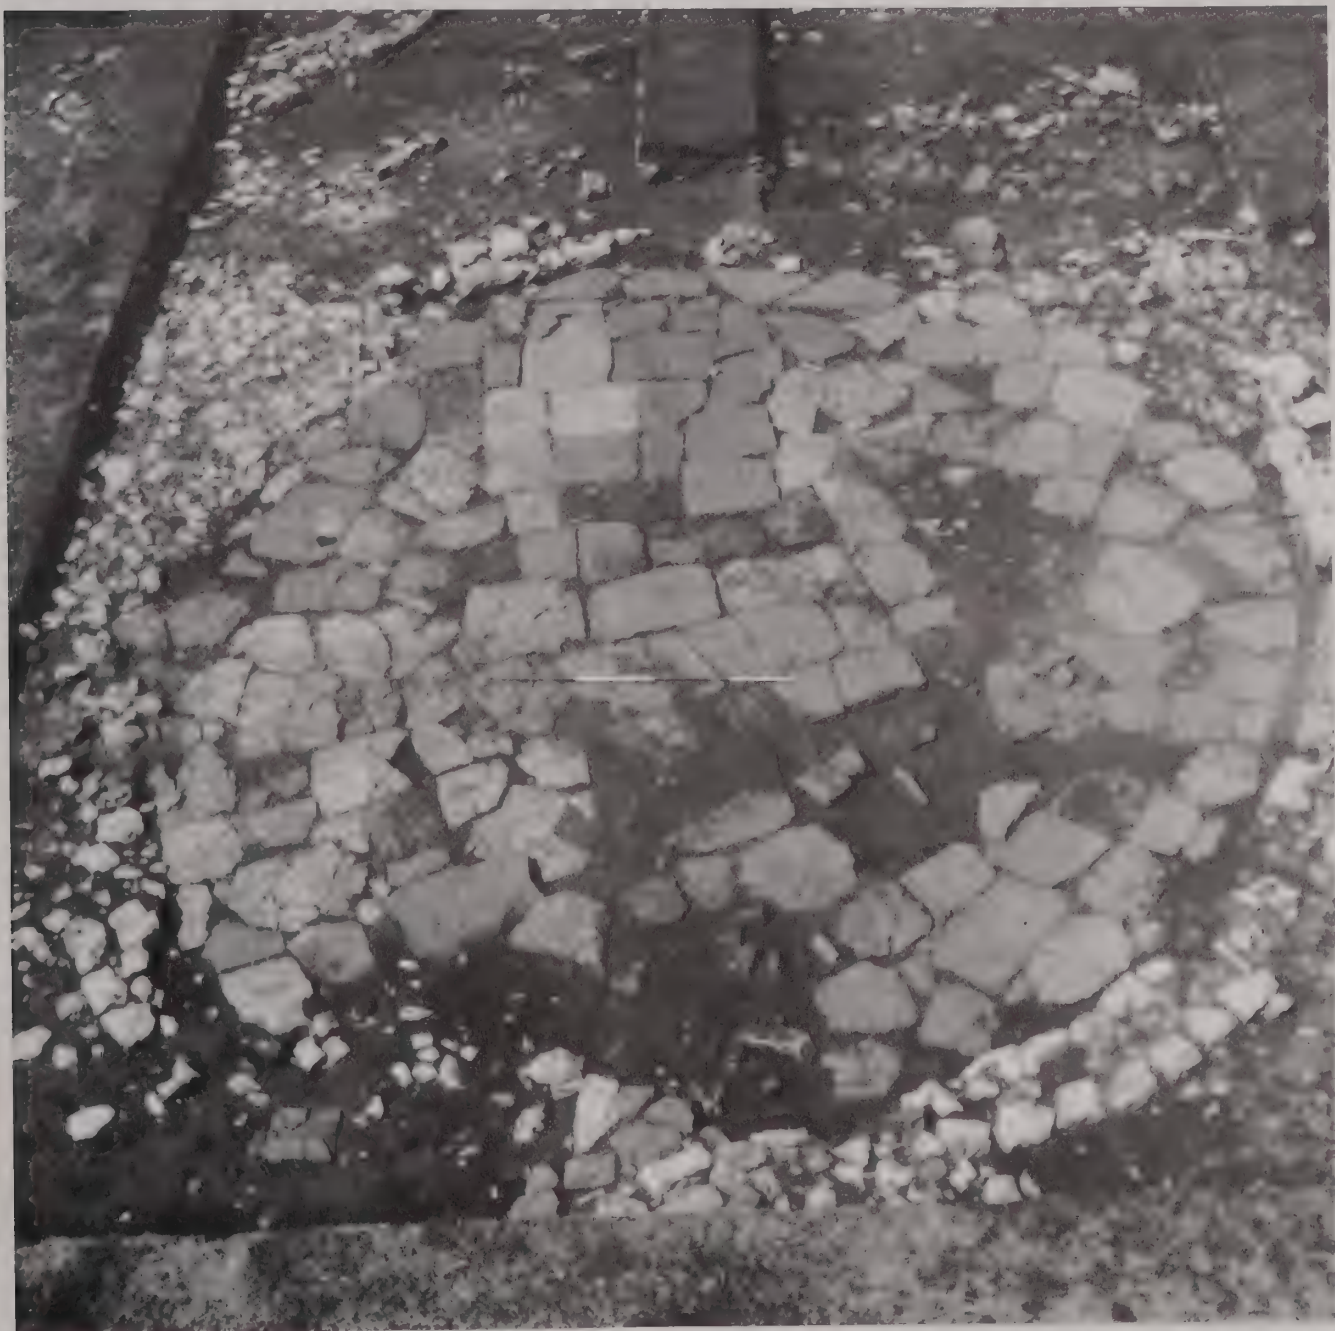
Fig. 29 Overall view of Building 6. View north.

This was a circular building situated to the west of the courtyard wall with its east side separated from it by about 0.50m. It was slightly oval; its north-south diameter was 9.00m and its east-west diameter about 8.40m. Its walls were 0.60m wide and constructed in tabular limestone facings with a rubble

core. It had the finest stone floor found in any of the buildings; it comprised a series of rectangular flags which in the centre and north side of the building were fairly carefully laid. However, to the east and particularly the west the flags were more irregularly set. Whether this was coincidence or evidence for repairs is uncertain. The pavement was also scarred in three places towards the east and south but the photographs (Archive Photographs 301-4, for example) are not sufficiently clear to confirm whether these breaks may have been the position of post-holes (but see below); they were not excavated. The entrance was on the north-west side where there was negative evidence for an opening since metalling, an extension of a nearby path, impinged slightly into the structure. The width of the entrance cannot be determined with accuracy.

Building 6 (Fig. 29)

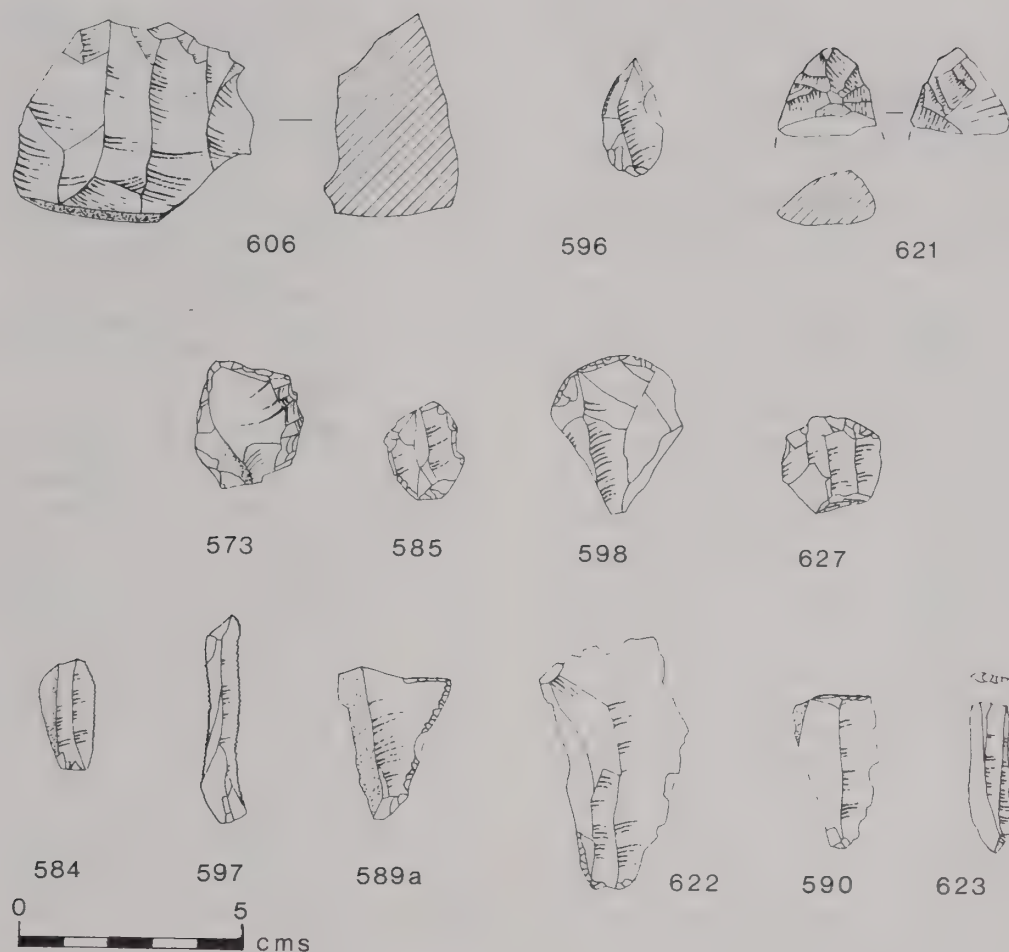
Fig. 60 The worked flint.

Fourteen items (23%) exhibit varying degrees of retouch while a further six (10%) bear traces of utilisation. This is an unusually high proportion (33%) of the total assemblage and further indicates that Beadlam was not primarily a flint knapping site but a location where stone tools were actually used. What knapping took place may have arisen from the maintenance of an existing tool kit. Most of the implements described below are illustrated in the accompanying figure (Fig. 60).

their manufacture such as micro-burins, makes such an early date unlikely. Blades are also common in Neolithic assemblages, particularly belonging to the later part of the period, while the Beadlam scrapers would not be out of place in a Late Neolithic or Early Bronze Age context, and a date for the whole assemblage between c. 2500-1500 B.C. may be tentatively suggested.

Prehistoric activity about the site is further attested by the presence of 57 worked flints found in the vicinity of the East Range (see below p. 116). A leaf-point and knife fragment suggest a date between c. 3500-1500 bc while a tentative date of c. 2500-1500 bc is given for the blades and scrapers. Although the assemblage may not be contemporary, nor belong to a single period of activity, the quantity of material indicates that the site was more probably the scene of procurement activities while the focus of the settlement possibly lay nearby.
